Manhole Inspection Summary

Manhole # S31S1_021MH

Insp Date: **2/15/08 1:13 PM**

Location Address: **1363 Spelman Road**

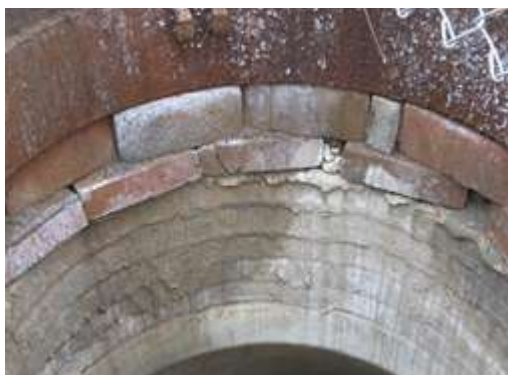
Defect 1

Condition: ☐ Sound ☐ Cracked ☐ Root Intrusion ☒ **Loose Brick** ☐ Deteriorated

Infiltration: ☐ None ☒ **Joint** ☐ Cracks ☐ Mortar ☐ Roots ☐ Wall

Chimney

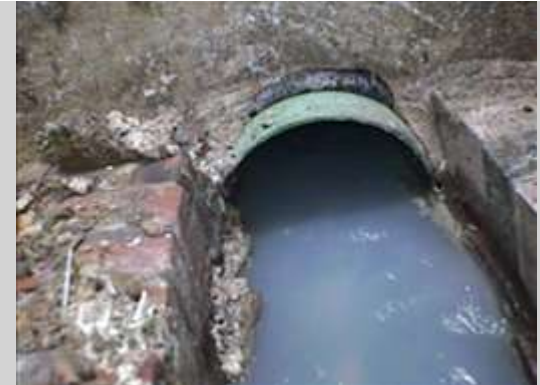
12 O'Clock Outflow

8 in. Circular Gravity Sewer
Pipe Out @ 12 O'Clock

Pipe Height: **9.6** (in.) Rod and Bar (Angled)
Pipe Material: **PVC** ☐ Pipe Lined
Invert Depth: **12.14** (ft.) Flow Characteristics: **Fast**
Deposits: ☒ None ☐ Mud ☐ Sludge ☐ Debris ☐ Grease
Silt Depth: (in.) Deposits Extent:
Infiltration: **None** Pipe Seal Cond: **Sound**

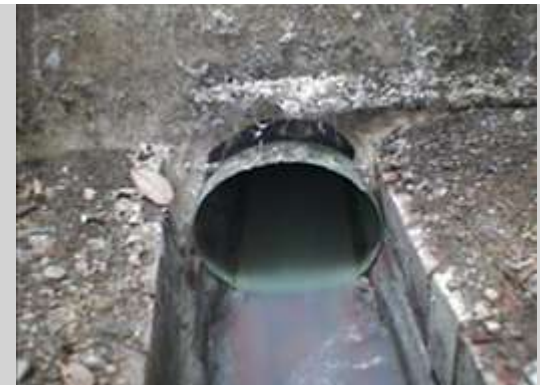
6 O'Clock Inflow

8 in. Circular Gravity Sewer
Pipe In @ 6 O'Clock

Pipe Height: **9.6** (in.) Rod and Bar (Angled)
Pipe Material: **PVC** ☐ Pipe Lined
Invert Depth: **12.09** (ft.) Flow Characteristics: **Fast**
Deposits: ☒ None ☐ Mud ☐ Sludge ☐ Debris ☐ Grease
Silt Depth: (in.) Deposits Extent:
Infiltration: **None** Pipe Seal Cond: **Sound**
